Cambria Community Services District

Board of Directors Regular Meeting
December 14, 2017

Facilities & Resources Department

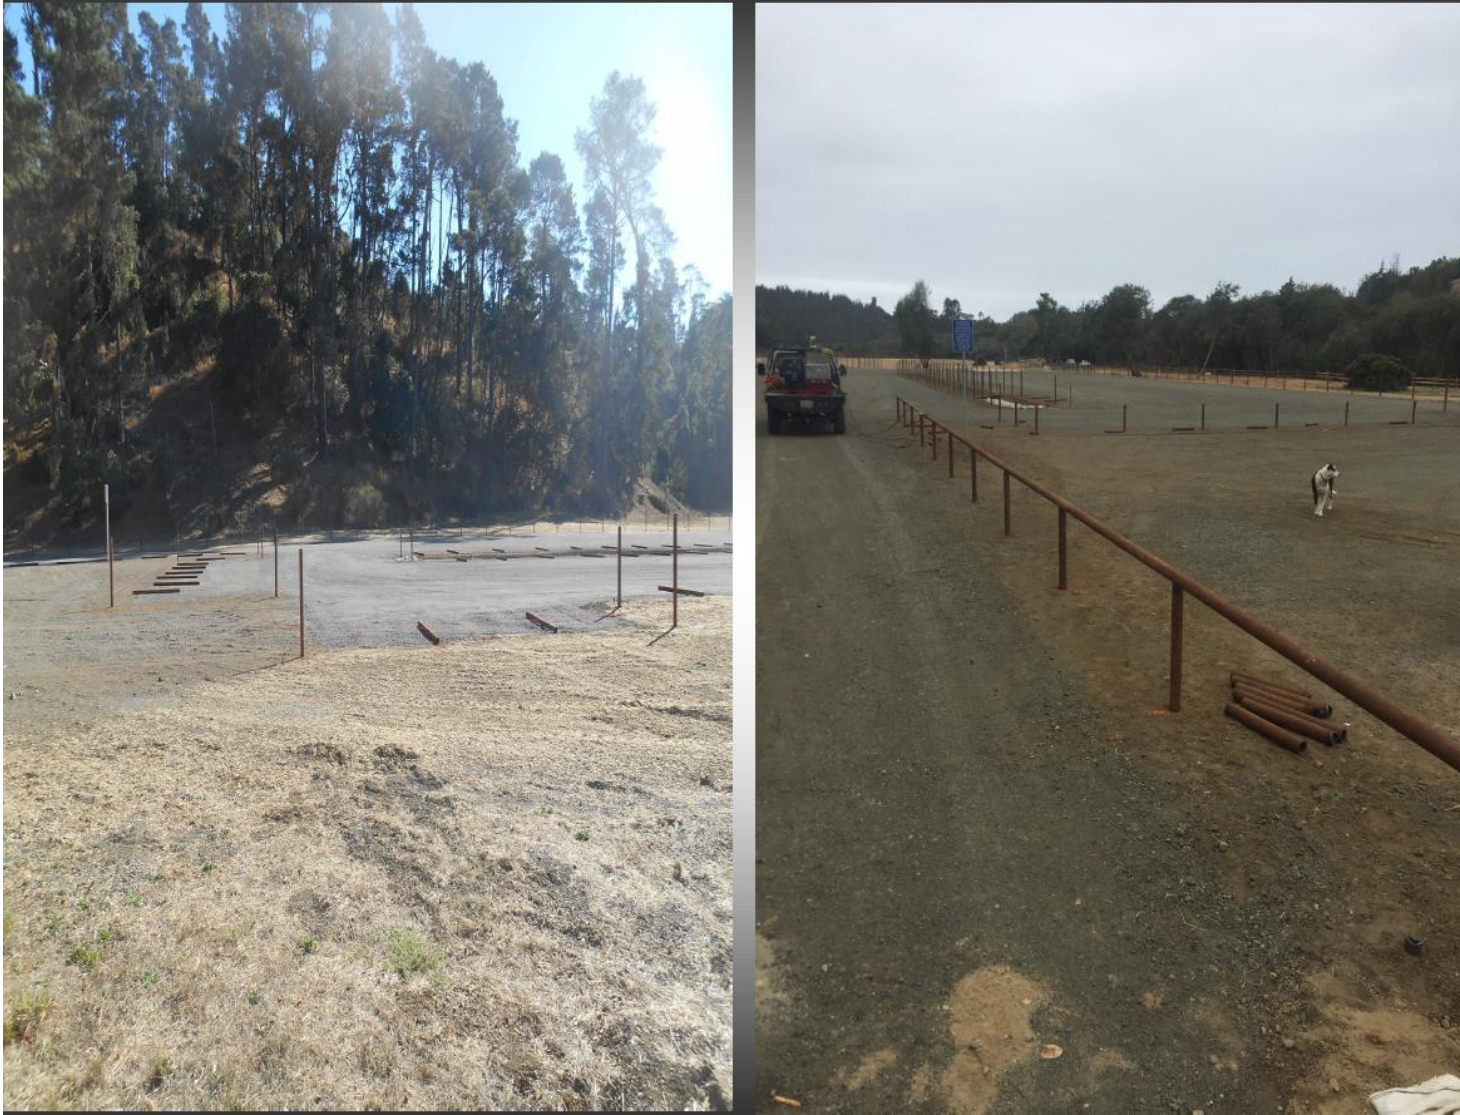
The staff has been working on the park to get it ready for the grand opening. Pictures include delineation of the parking lot, cobble stone placement on middle drainage area, delivery and spreading of wood chips and installation of boulders.

We were supposed to get a delivery of cobbles to finish off the middle drainage, but unfortunately the delivery truck broke down and could not deliver them. They should be here next week. This is the final item to be completed.

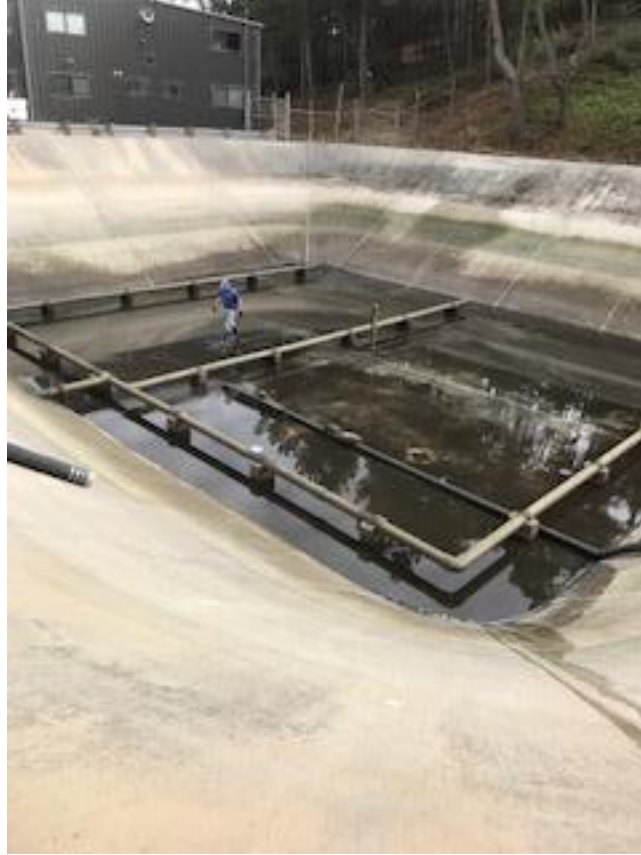
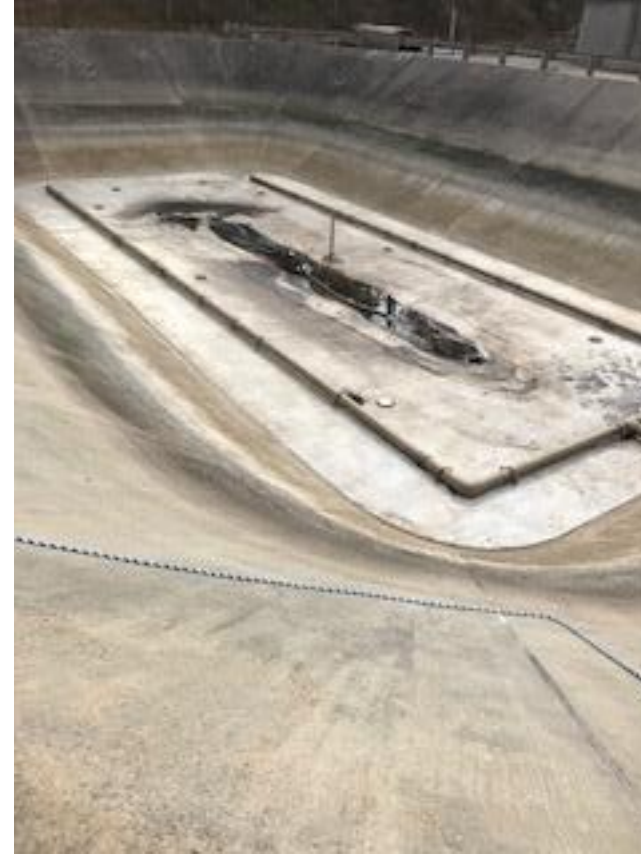
The department emptied and cleaned all three ponds in preparation of the winter rains.

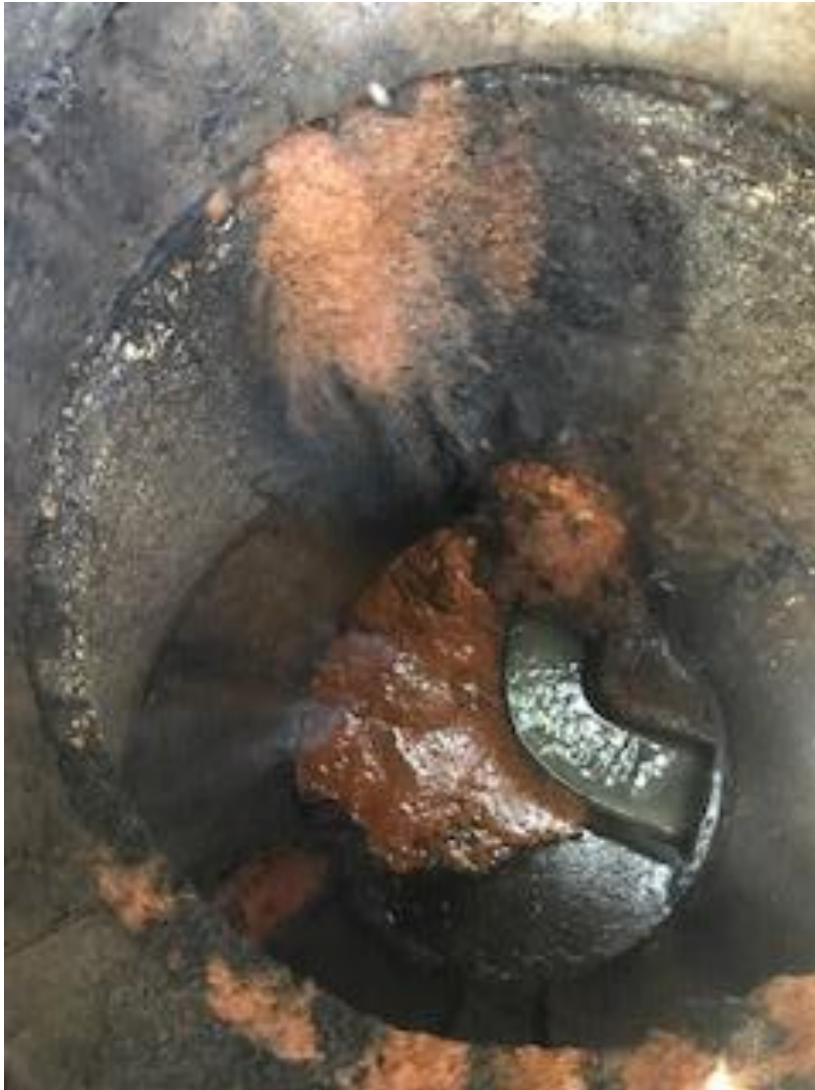
This manhole is one of the manhole we have identified as having problems. The manhole is leaking water even during the dry season. The cost to repair the leak is \$6,000 and we have several just like this one. The leak is coming from the connection 4 feet up from the bottom. This is not something that replacing the lid can fix.

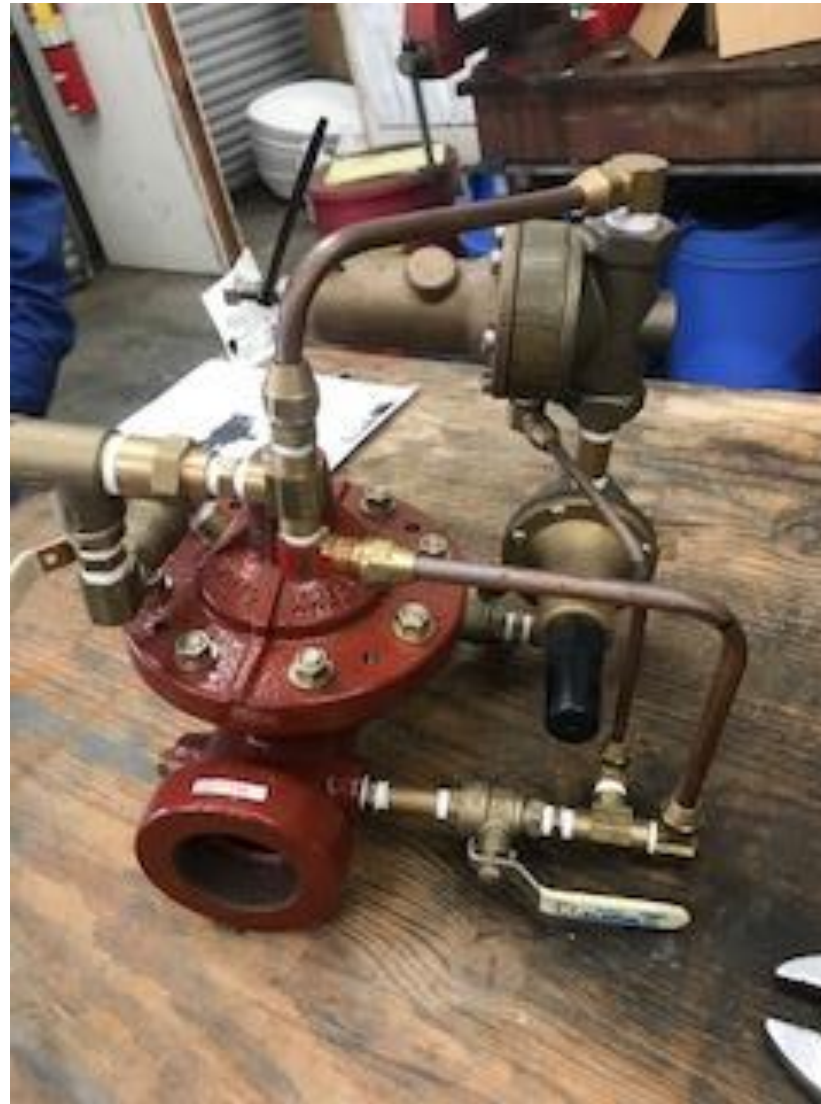
This pressure relief valve will be used on the non-potable water system.

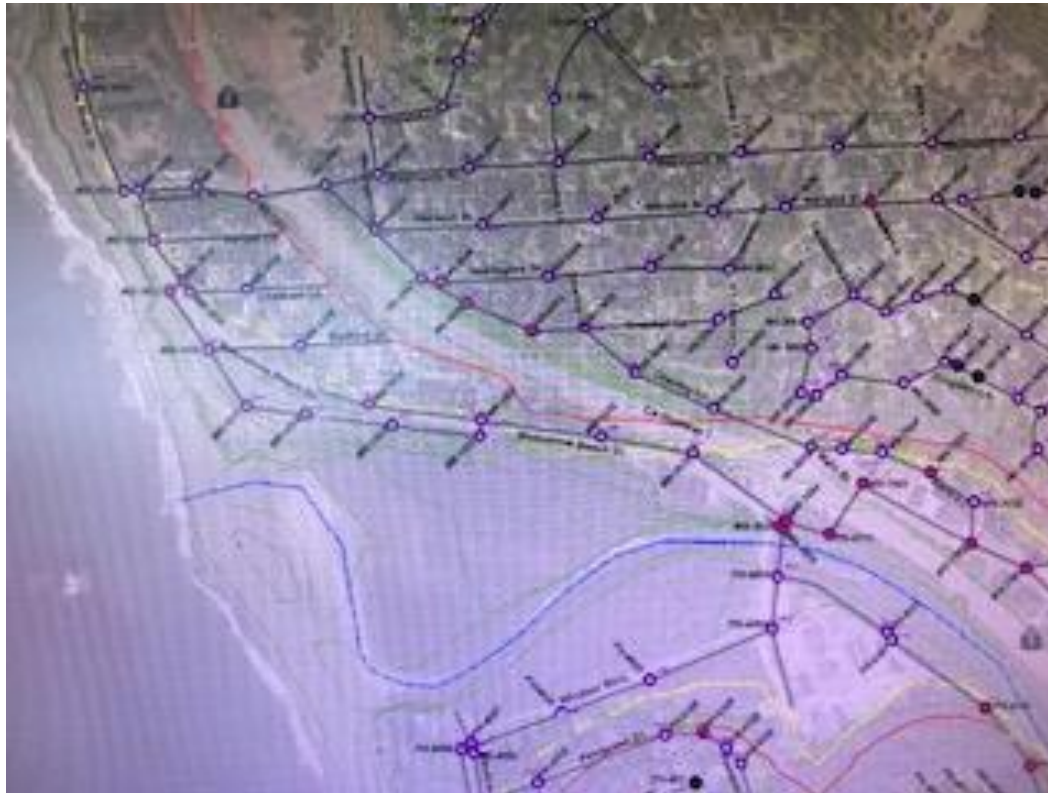
This is a snapshot of the GIS map for the collection system. This program has been one of the most helpful things added to the collection system. The department can step onto a manhole and find out what needs to be done and what has been done over the last year.

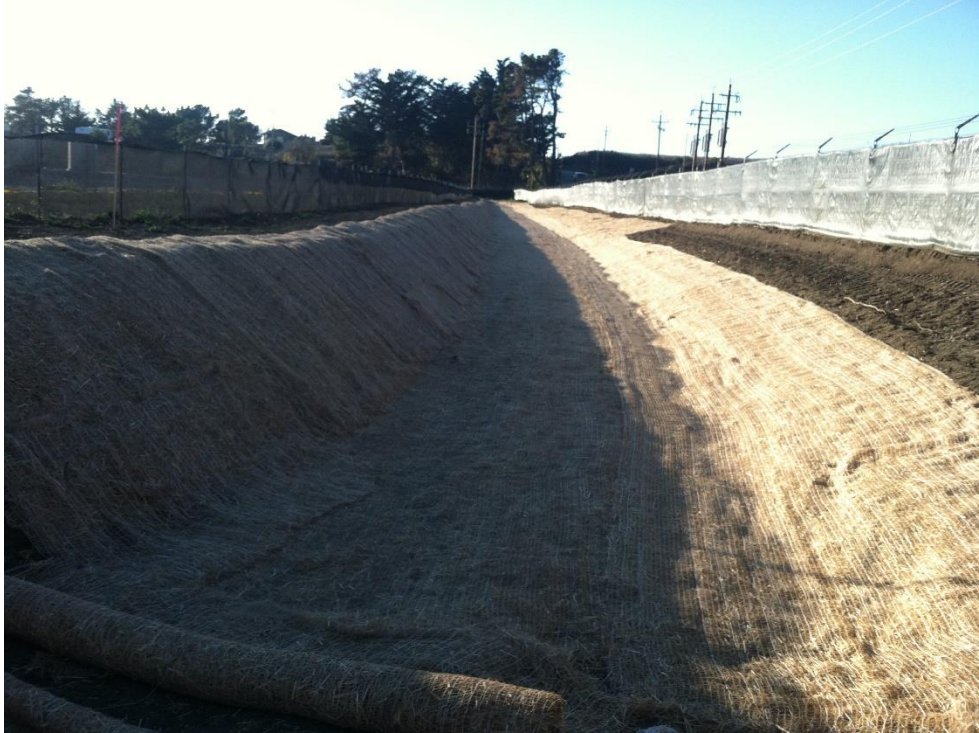
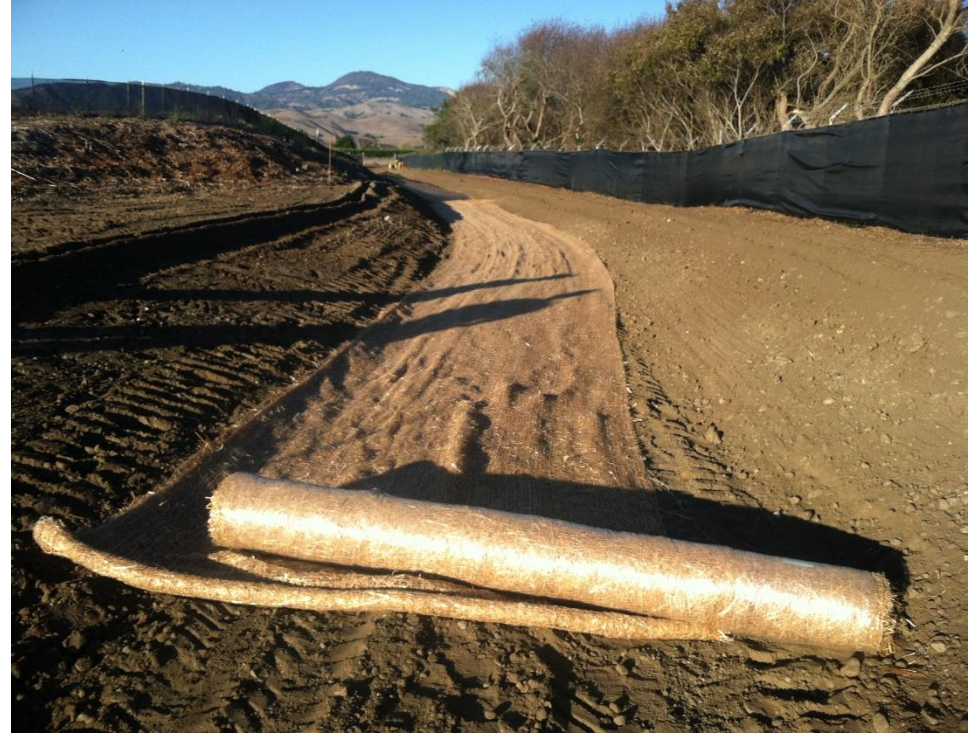
Liner work is complete along the north side of the basin. Liner work is continuing on swale to the east of the impoundment basin.
