CAMBRIA COMMUNITY SERVICES DISTRICT

Board of Directors Regular Meeting

January 18, 2018

Water Department – Stuart Street Tank Project

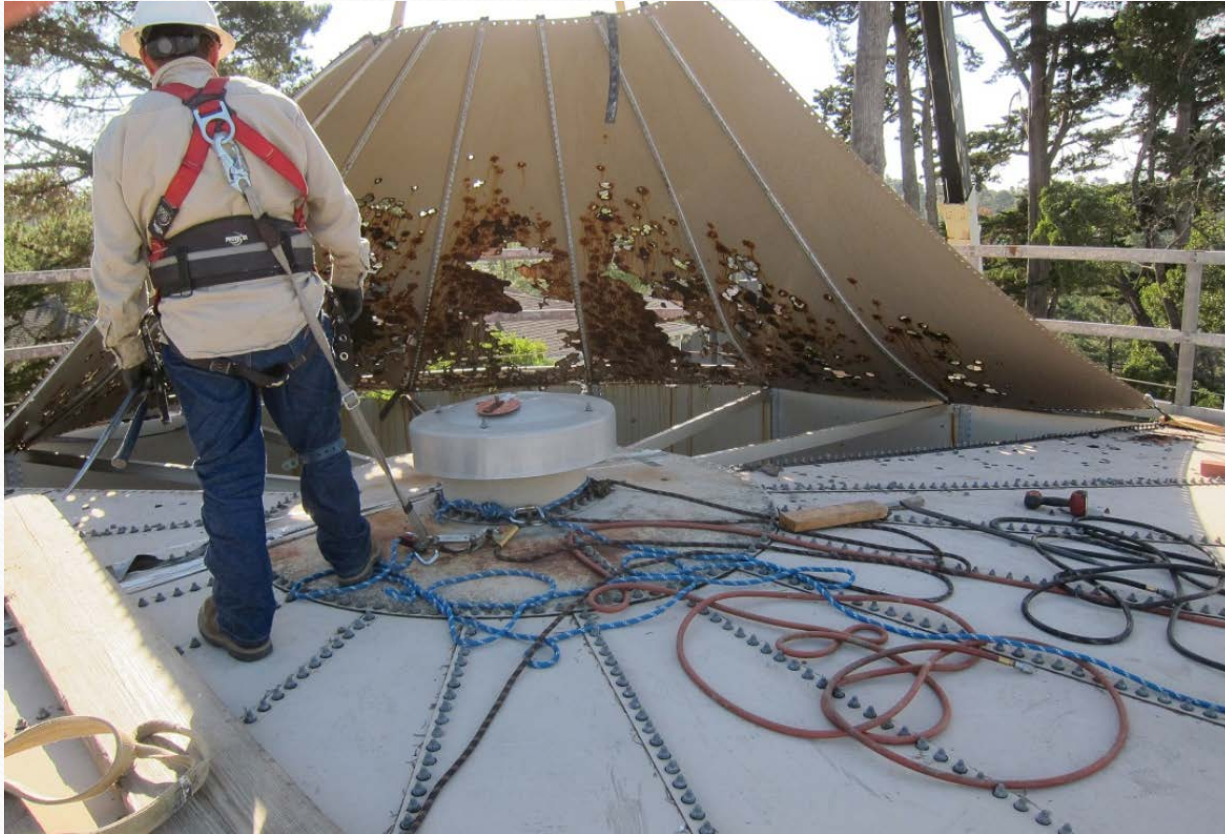
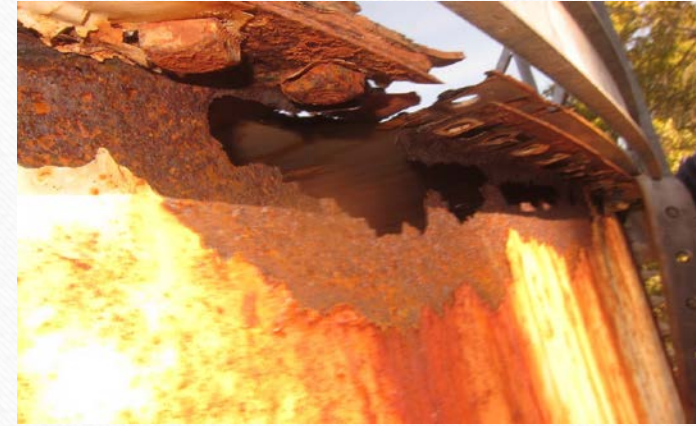
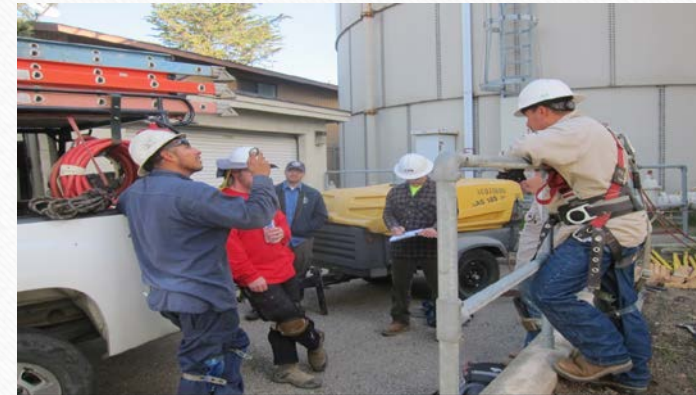
Superior Tank removed the most severely corroded roofing. After removal of the roof and a bunch of the rust scale, it was determined that 3 shell panels were too far gone to bolt to. Everyone agreed that changing the contract to add the replacement of those shell panels would increase the likelihood that this tank can stay in service for the desired 5 more years. The cost and schedule to change out the panels while Superior was on site, with the adjacent roof off, is significantly lower than having them come back later.

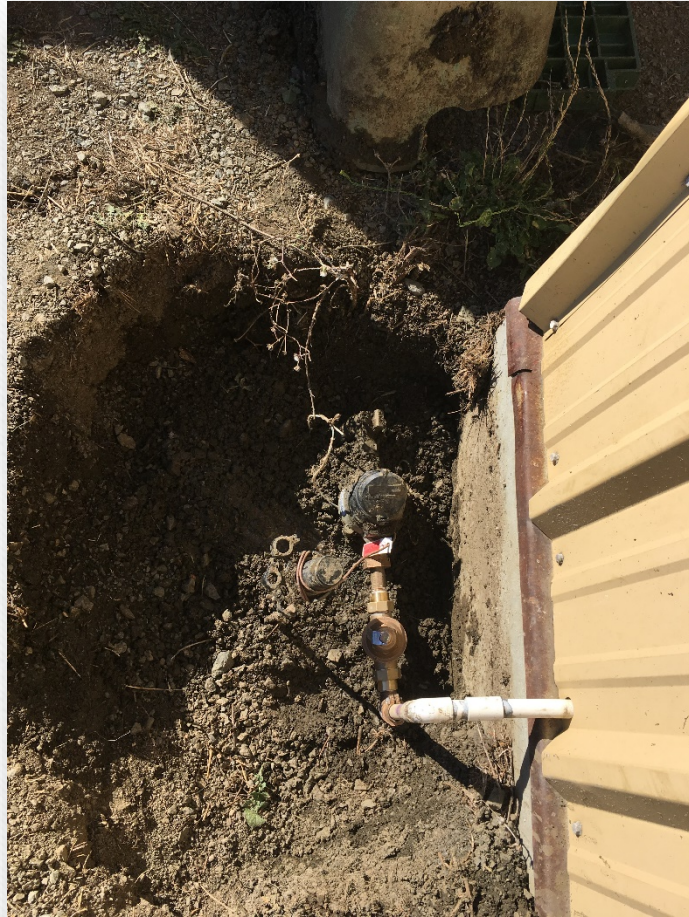
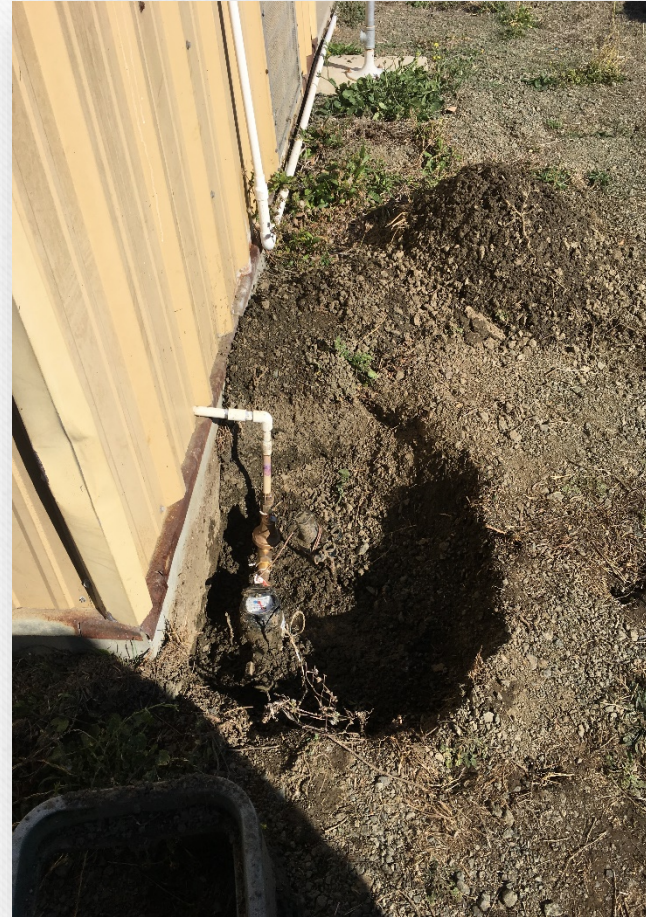
This pressure regulator is located at SS3. The water that goes through the regulator is for the chlorine analyzer and the turbidimeter for the entire SS wellfield.
